Immediate Action Required User Safety Notice SN052022

3M™ Scott™ Air-Pak™ X3, Air-Pak™ X3 Pro, and X3-21 Pro Self-Contained Breathing Apparatus

November 1, 2019 – April 12, 2022

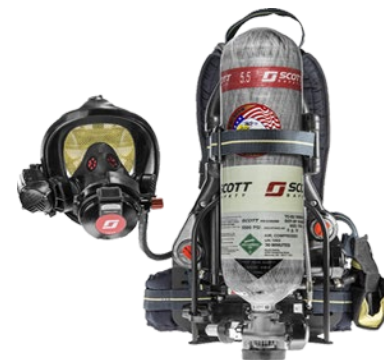
To confirm that you have an SCBA included in this User Safety Notice, please verify that your Air Pak X3, X3 Pro, or X3-21 Pro SCBA reducer was manufactured between 11/01/2019 and 04/12/2022. Reference **Figure 1** for an example of how to identify the mfg. date of your pressure reducer (the location and format of the serial number label is identical on all models).
